# Manhole Inspection Summary

Manhole # S39C\_\_034MH

Insp Date: **1/10/08 10:46 AM**

**Location** Address: **215 st matthew st**

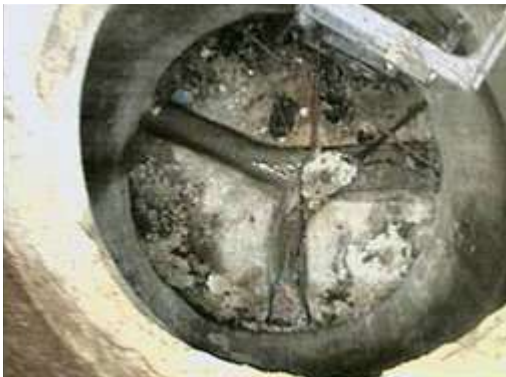
Defect 2

Infiltration: ☐ None ☒ **Joint** ☐ Cracks ☐ Mortar ☐ Roots ☐ Wall

infiltration from barrel joint

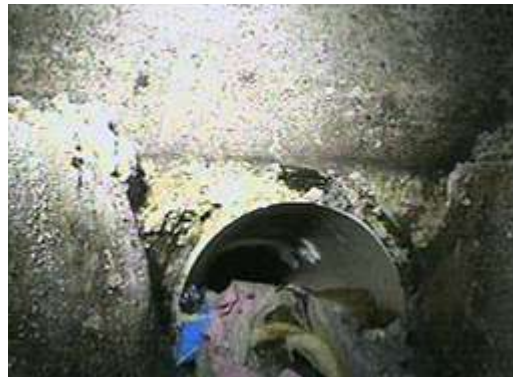
Defect 1

Condition: ☐ Sound ☐ Cracked ☐ Root Intrusion ☐ Deteriorated ☐ Leaks ☒ **Debris**

Channel Debris

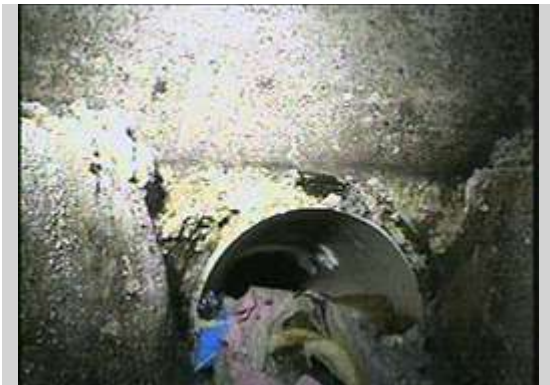
3 O'Clock Inflow

Deposits: ☐ None ☐ Mud ☐ Sludge ☒ Debris ☐ Grease

Silt Depth: 4 (in.) Deposits Extent: Heavy

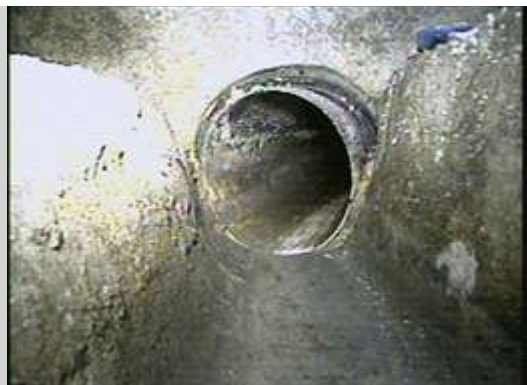
7 O'Clock Inflow

Deposits: ☐ None ☒ Mud ☐ Sludge ☐ Debris ☐ Grease

Silt Depth: 1 (in.) Deposits Extent: Light
